AON SPRINKLER CERTIFICATION

Aon Sprinkler Certification Technical Note

Note Number: TN-20-45	Issue: 1.1	Date: 19 August 2020
Subject	Pump House Pipe Work	
Notice: Aon Sprinkler Certification Technical Notes provide guidance notes which may be used in certification of sprinkler installations by Aon New Zealand. If sprinkler installations are being certified by any other Sprinkler System Certifier, these Technical Notes may not apply.

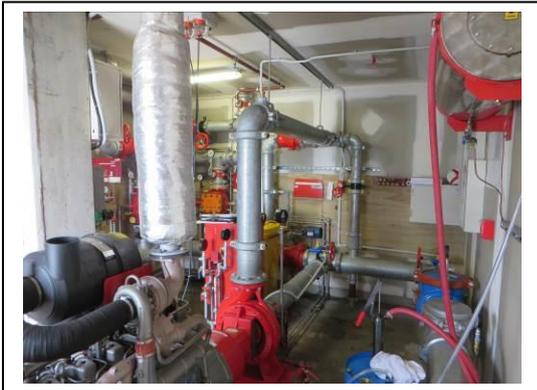
This photograph shows a pump installation of approximately 10 years ago, that was never certified. The issues with bracketing and bracing are numerous to most untrained eyes.

It is pleasing to see that after some publicity, we are seeing improvements in pump house bracketing. It is now common practice to support pump house pipework from floor mounted frames. However, the detailed design of the supports cannot be left to fitters. The design needs to consider the potential vertical loads on the supports but also the need to provide four-way seismic bracing.

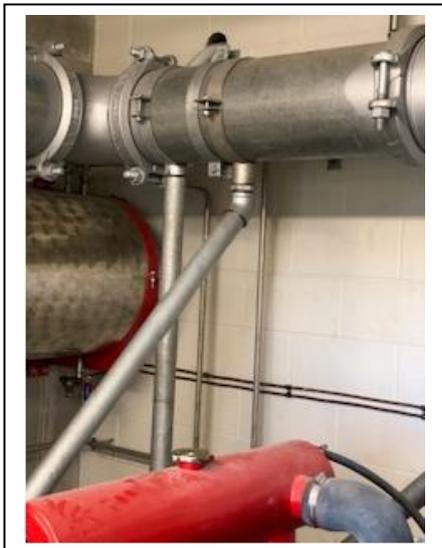
This photograph shows bracing on a 200mm pipe in a pump house.

- The method of attaching the brace is best described as interesting. We are unaware of any published data showing the load capacity of a 45°-malleable iron elbow.
- Under NZS4541:2020, the pipe clamp itself will require to be listed for seismic bracing.
- While not shown in the photograph, the pipework is not provided with any longitudinal seismic bracing.
- One could question why an investigation was not carried out to check if the lateral brace could have simply been fixed to the block wall.
- With a tall skinny column there is risk of buckling.

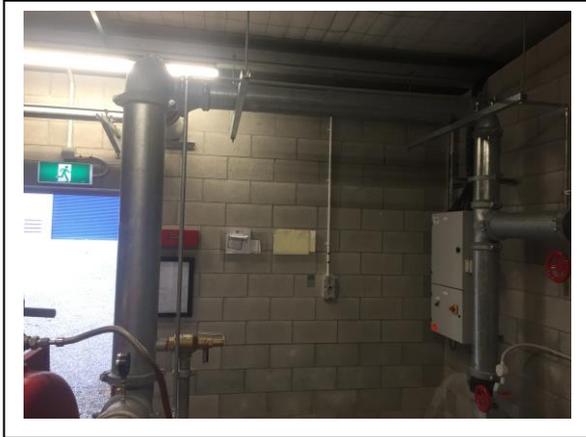
This photograph shows 150mm mains, sitting on a trapeze hanger.

We would question whether the loads on the structure is adequate to support the loads?

Lack of seismic bracing?

If fixing pipes to pump-house walls, the load capacity of “Unistrut” type cantilever brackets needs to be checked. These standard “of the shelf brackets” have limited load capacity. In addition, the pipe may require additional bracing to deal with longitudinal loads.

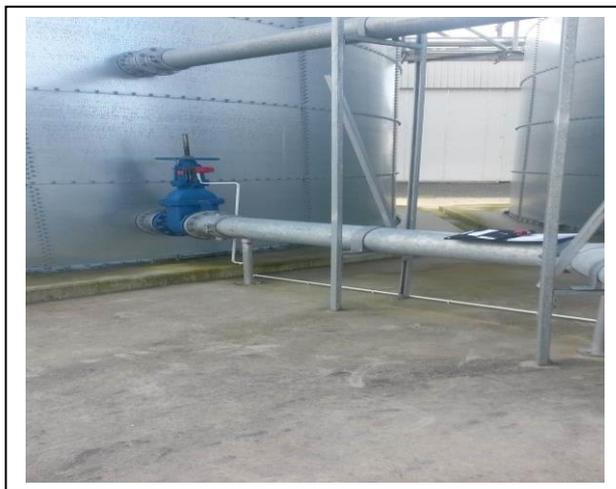
This photograph shows a pipe support which appears to be fabricated out of “Unistrut” type channel.

Intuitively, it appears to be too light to act as a column and is probably being supported by the pipe.

A support such as this should be designed by an engineer, accounting for gravity, seismic and thrust loads.

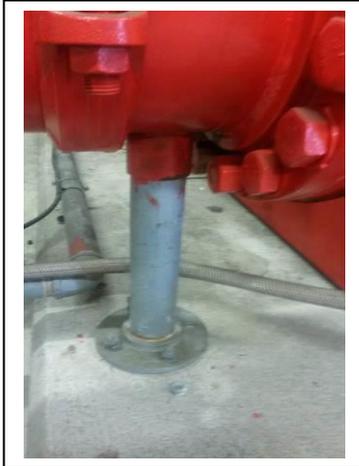
There are a number of issues with this pipe upstand:

- 1) The fixtures have been drilled and installed on an angle
- 2) Missing fixtures. Is this as per design, or have the fitters missed this.
- 3) Use of a flange does not allow the separation distances mandated by the fastener manufacturer's data sheet to be met.

Use of a socket welded to a piece of flat steel would have allowed:

- 1) The holes to be drilled perpendicular to the floor
- 2) The minimum distances between fasteners to be met.

The following analysis should be completed on brackets in fire pump rooms:

- Bending moment of the bracket
- Turning moment being applied to the fixing.
- Column buckling

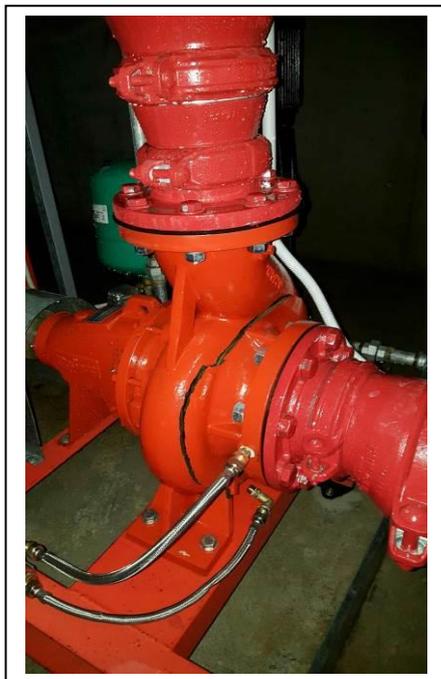
The consequences of getting it wrong can be horrendous. This photograph shows the result of a poorly designed test return, where the butterfly valve failed and slammed shut resulting in water hammer. The water damage from the split pump resulted in a six figure insurance claim.

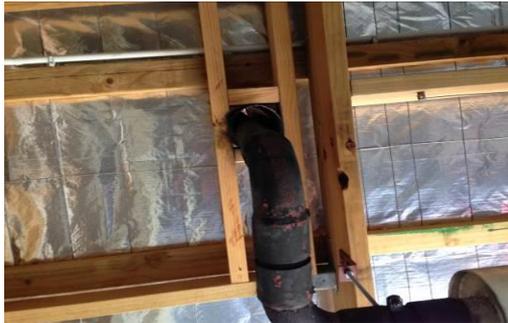
Even minor details such as exhaust runs can be problematic. This exhaust pipe is intimate with the timber framing and is exhibiting signs of pyrolysis.

We are also noting that other trades may fix their services near exhaust pipes. It is common to sight lights and conduit in close proximity to a hot exhaust.

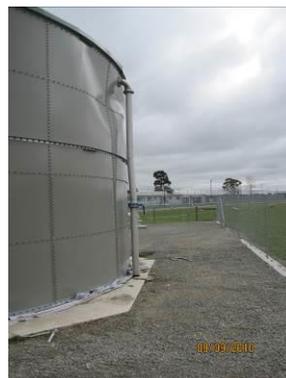
This photograph shows damage caused by rigidly welded pipework entering the top of a tank following the 2010 Christchurch earthquake. This could have probably been avoided if:

- Flexibility was introduced into the pipe work; and
- The pipe entered the tank at the bottom rather than the top.
