Aon Sprinkler Certification Technical Note

Note Number: TN-21-52	Issue: 1	Date: 3 March 2021
Subject	Pump Test Orifice Plates – Safety Warning	
Notice: Aon Sprinkler Certification Technical Notes provide guidance notes which may be used in certification of sprinkler installations by Aon New Zealand. If sprinkler installations are being certified by any other Sprinkler System Certifier, these Technical Notes may not apply.

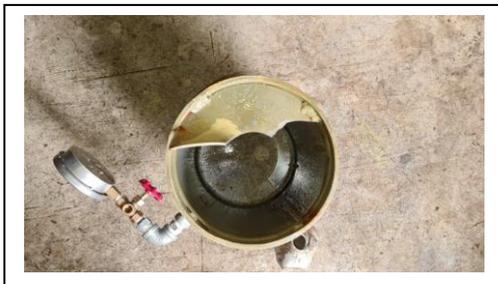
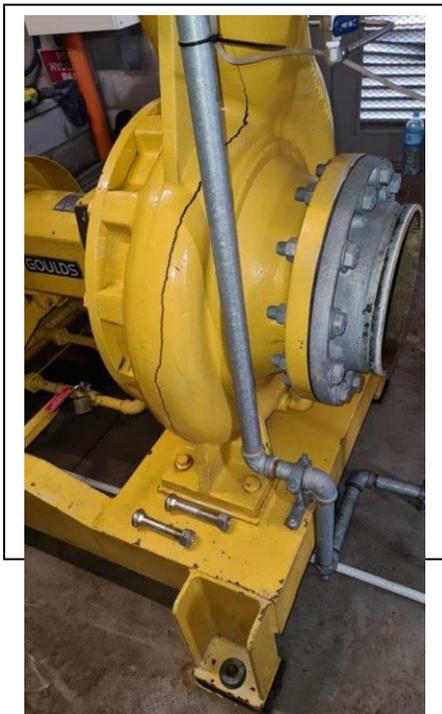
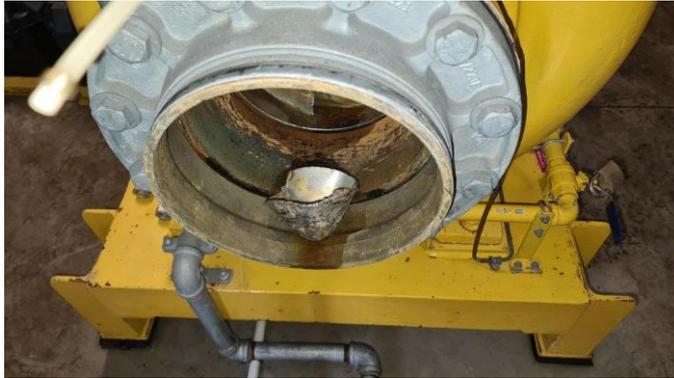
Aon has been alerted to an incident where it appears that a pump test return orifice plate has failed, dislodged and jammed a pump impeller, resulting in the casing splitting while the pump was being tested.

The orifice plate was fabricated out of stainless steel, and was tack welded against a roll groove.

1. The stainless-steel plate appears to be approximately 3mm thick. This does not comply with the minimum thickness specified in NZS4541.
2. Welding stainless steel to mild steel is not a straight-forward exercise. The surfaces need to be adequately prepared, the correct filler materials need to be selected, and the finished weld needs to be adequately protected against corrosion.
3. In this installation, the finished orifice plate has been installed with the plate downstream of the water flow. While this installation was installed in compliance with NZS4541:2013, intuitively, we would have expected that the orifice assembly be installed with the plate upstream, as required by NZS4541:2020.
4. We are uncertain whether best practice has been followed and the orifice plate is marked with an arrow indicated direction of flow as is now required by NZS4541:2020.

Aon recommends that contractors who have installed orifice plates of this design, or those testing sprinkler systems using such orifice plates in the test return, ascertain if they are at risk of injuring or harming people or property, so that appropriate remedial action can be undertaken.
