## Aon Sprinkler Certification Technical Note

<b>Note Number: 15-17</b>	<b>Issue: 1</b>	<b>Date: 30 June 2015</b>
<b>Subject</b>	<b>Concealed Plate Heads</b>

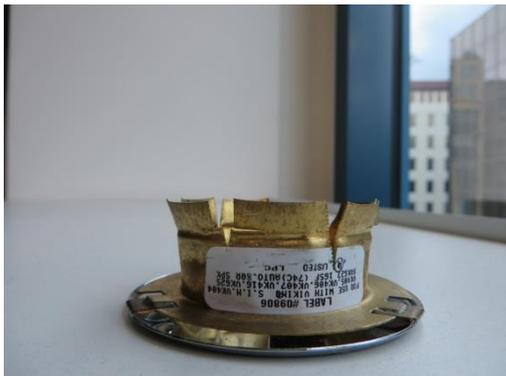
Concealed Sprinkler Butchered to fit a standard spray sprinkler.

Aon is recommending that during new construction, that the plates not be fitted off until the finishing trades have completed and the quality of the installation is audited by the inspection company. It is noted that this may not be practicable in all cases, especially in areas such as hotel ball rooms and the like, where scaffolding may be required to fit off the plates.

Aon also recommends that during biennial inspections (or annual inspections for installations installed in compliance with NZS4515) that where practical, that inspection companies remove a number of plates to ascertain whether any defects are not readily visible.

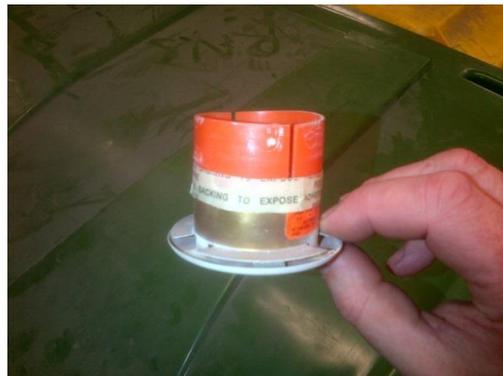
Concealed sprinkler extended due first fix fitout height error
