AON SPRINKLER CERTIFICATION

Aon Sprinkler Certification Technical Note

Note Number: TN-20-45	Issue: 1.1	Date: 19 August 2020
Subject	Pump House Pipe Work	
Notice: Aon Sprinkler Certification Technical Notes provide guidance notes which may be used in certification of sprinkler installations by Aon New Zealand. If sprinkler installations are being certified by any other Sprinkler System Certifier, these Technical Notes may not apply.

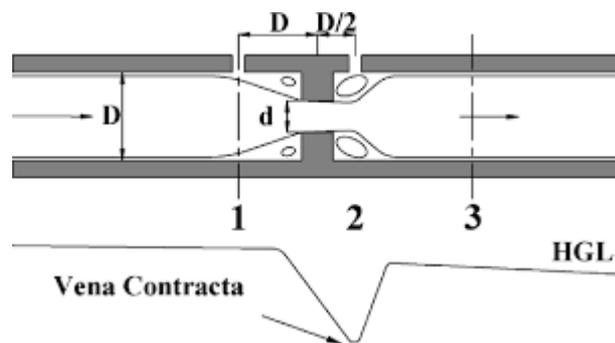
The drop in fluid pressure can be considerable, especially if the fluid velocity is high, and the orifice is small. This can lead to cavitation, which will result in damage to the pipe work and valves. The theoretical losses can be determined using Bernoulli's equation.

To avoid this, it may be necessary to install multiple orifice plates, which will require straight lengths of pipe work between them.

Installation of pressure gauges upstream and downstream of an orifice plate will assist to validate performance.
