Aon Sprinkler Certification Technical Note

Note Number: TN-18-37	Issue: 1	Date: 23 February 2018
Subject	Flow testing considerations	
Notice: Aon Sprinkler Certification Technical Notes provide guidance notes which may be used in certification of sprinkler installations by Aon New Zealand. If sprinkler installations are being certified by any other Sprinkler System Certifier, these Technical Notes may not apply.

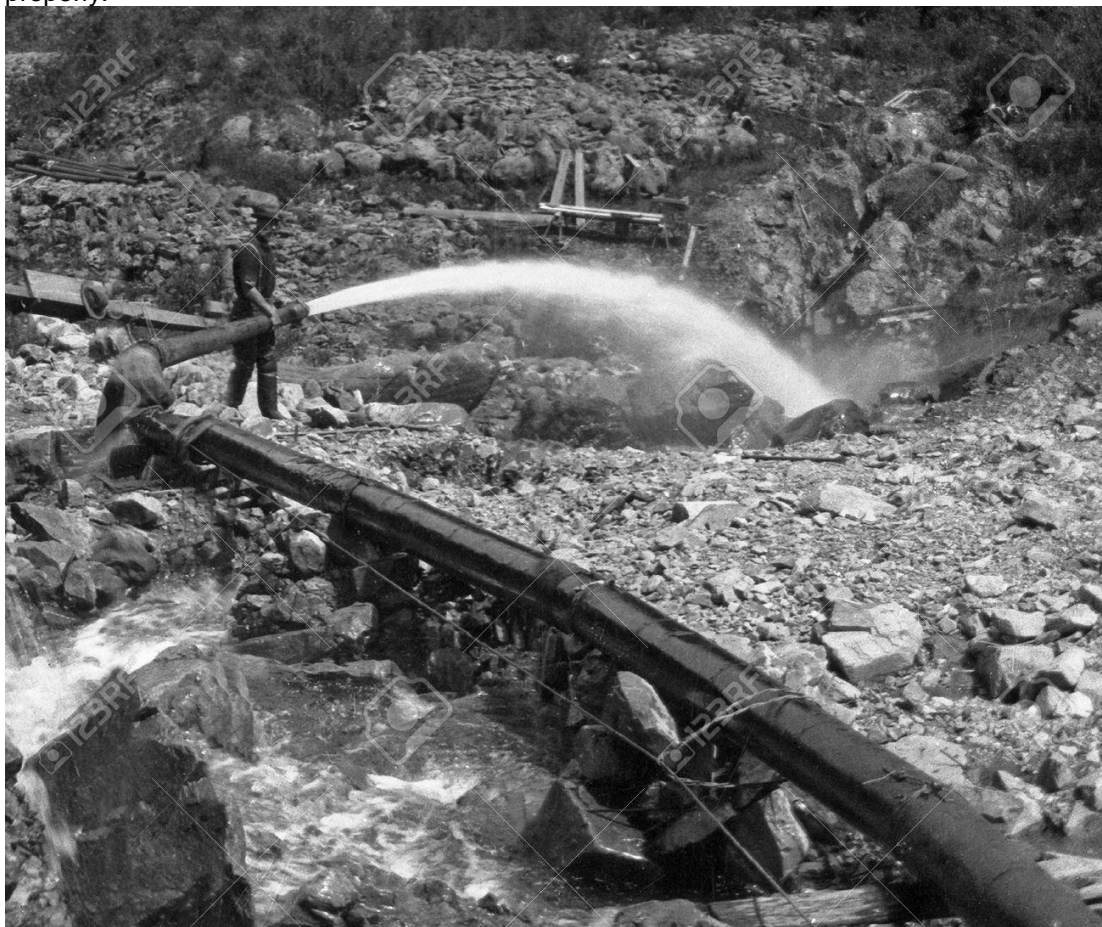
For systems with high flow rates, the flow test can look quite impressive but these tests can also potentially be very destructive. The flows generated are similar to those used by gold miners to wash away rocks and soil and can cause significant damage if not managed properly.

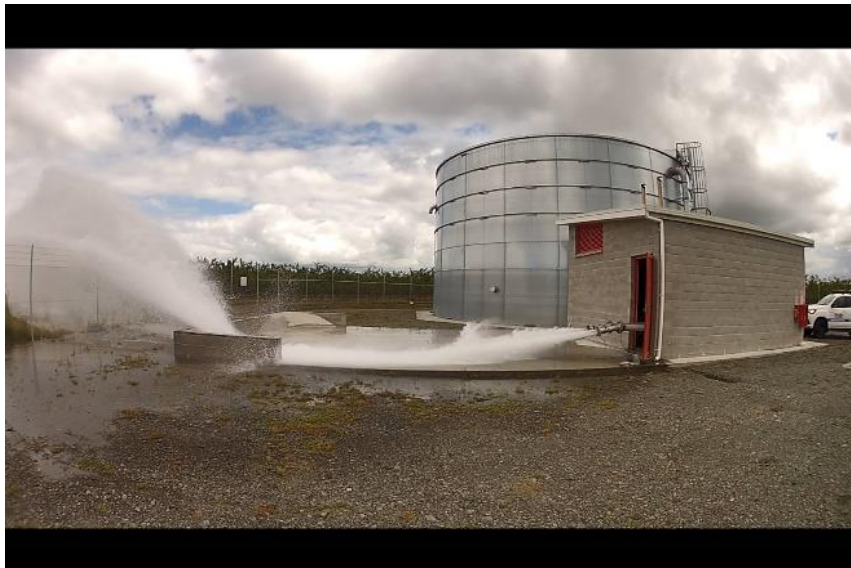
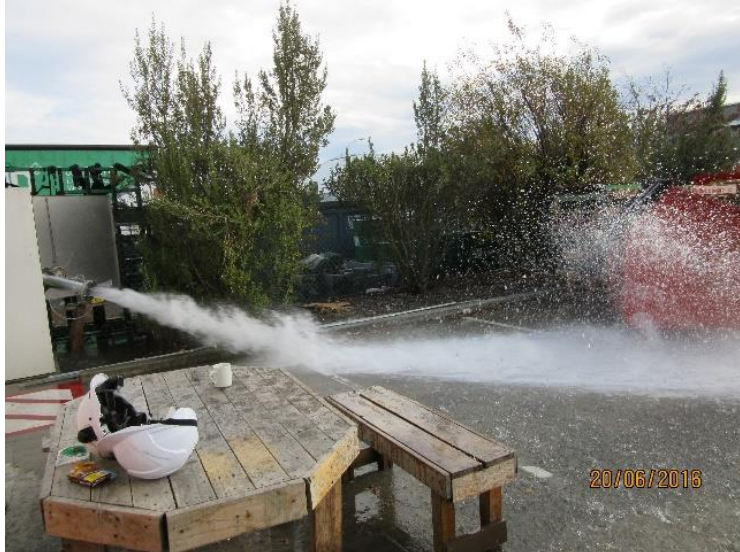
In particular, the surface that the water will discharge on must be considered in the design of a sprinkler system and when conducting the flow tests. A common failure point is the joints between asphalt and concrete as the water may be forced under the lip of the seal. For very high flow test volumes, as is now common in warehouses, asphalted areas can be torn up and destroyed.

Soft landscaping features located in front of the water flow can also quickly be destroyed by a flow test. Additionally, the water run-off must be considered to avoid washing away garden mulch, flooding property and buildings and/or ponding or damaging the road and footpath.

Architects, landscape designers and fire contractors need to consider the design of the ground coverings in the area of the flow test point and where the test point is facing.

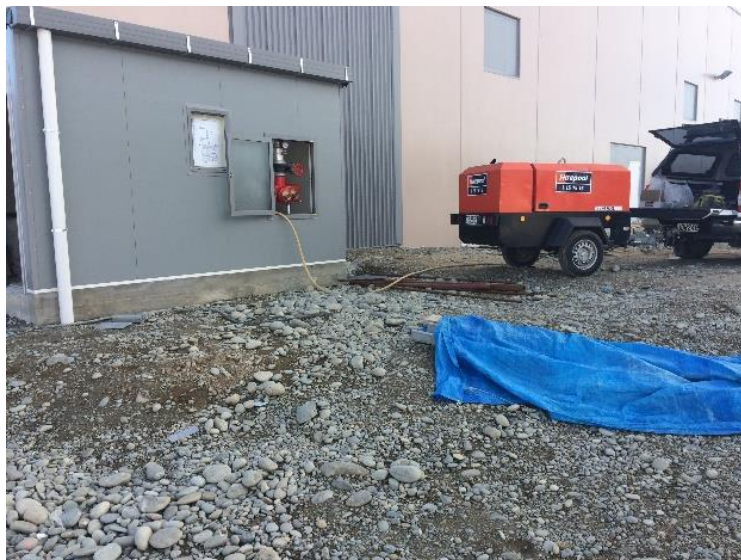
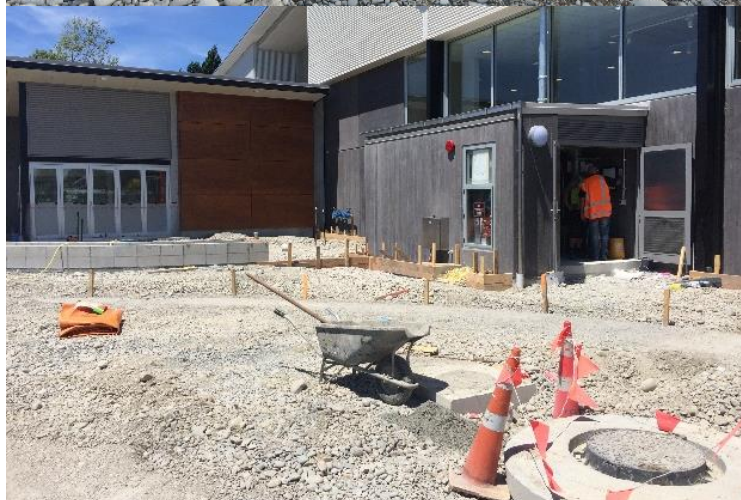
When preparing their construction programmes, head contractors, need to coordinate the timing of the flow test at the completion of the building with the civil works status on the site. This avoids the invidious situation of having to decide between delaying a flow test, and potentially the opening day of the building, versus tearing up the prepared landscaping or soaking prepared compacted base layers.
